**Flood Control Project Maintenance  
Levee Inspections**

**Fall 2016 Levee Maintenance Deficiency Summary Report**

**Sacramento River Basin**

**City of Sacramento**

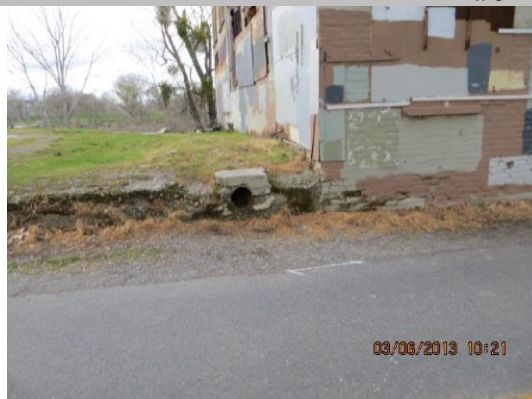
Photo 1 of 2 : UCIP\_FA\_2016\_40848\_72633.jpg

LM Start	<b>0.22</b>	Rating **	M	Issue No.	<b>859 (cont)</b>
LM End	<b>0.22</b>	Issue Type +	En	Location *	N/A

Pipe through levee visible next to building located on levee.

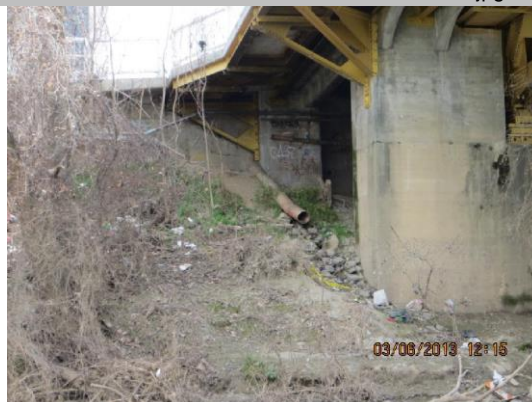
Photo 1 of 2 : UCIP\_FA\_2016\_41421\_72750.jpg

LM Start	0.74	Rating **	M	Issue No.	835
LM End	0.74	Issue Type +	En	Location *	N/A
Category	Supplemental			GPS Latitude/Longitude	
				Start	End
Item	DWR UCIP Field Study			38.580413 °	38.580413 °
				-121.507166 °	-121.507166 °
DWR ID					
Comment Code					
Inspector Comment					
FS_ID:41421 DS_ID:24905 EP_NO: N/A Repair Type: Non-Urgent Crossing Status: Indicator Found UCIP Comments: Need to contact owner to determine status and permit number for crossing. FIELD_STRUCT_DESC: Corrugated metal drainage pipe through floodwall visible on waterward side. FS Date: 3/6/2013

View of waterward side.

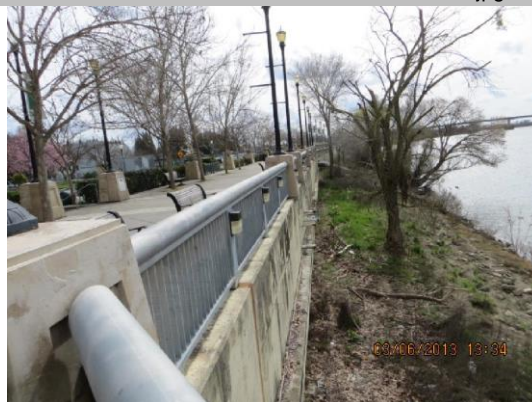
Photo 1 of 2 : UCIP\_FA\_2016\_41422\_72754.jpg

LM Start	0.81	Rating **	M	Issue No.	860
LM End	0.81	Issue Type +	En	Location *	N/A
Category	Supplemental			GPS Latitude/Longitude	
				Start	End
Item	DWR UCIP Field Study			38.579353°	38.579353°
				-121.507560°	-121.507560°
DWR ID					
Comment Code					
Inspector Comment					
FS_ID:41422 DS_ID:24908 EP_NO: N/A Repair Type: Non-Urgent Crossing Status: Indicator Found UCIP Comments: Need to contact owner to determine status, purpose for lines, and permit number. FIELD_STRUCT_DESC: Cluster of conduits through floodwall visible from waterward side. FS Date: 3/6/2013

View of levee just downstream from crossings.

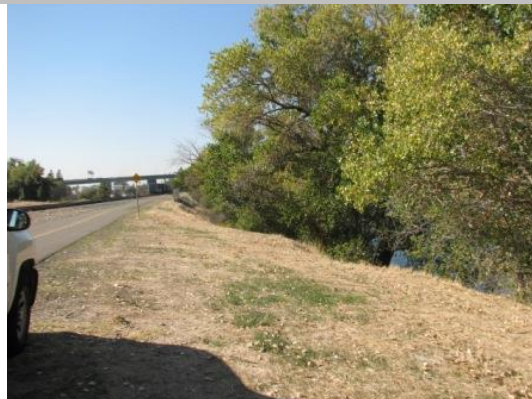
Photo 2 of 2 : FA\_2016\_NA0005\_251\_13\_20160913\_00011.jpg

LM Start	1.16	Rating **	M	Issue No.	13 (cont)	
LM End	1.69	Issue Type +	Ma	Location *	WS	
Category	Earthen Levee			GPS Latitude/Longitude		
				Start		End
Item	Trim / Thin Trees			38.574780 °		38.568757 °
				-121.510191 °		-121.515930 °
DWR ID	DWR_NA0005_01_f_2012_13					
Comment Code						
T2 : Thin trees to allow visibility of the ground and room to flood fight.						
Inspector Comment

Monitor the trees and woody vegetation along the rivers edge. Fall 2013

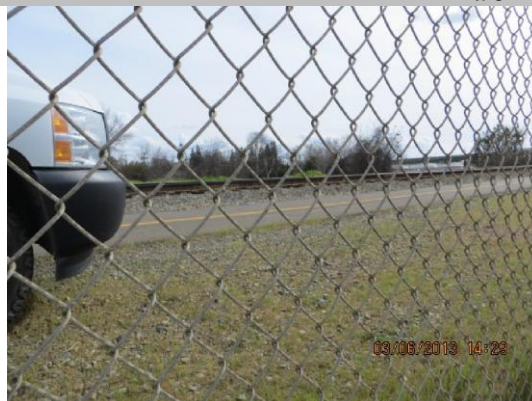
Photo 1 of 2 : UCIP\_FA\_2016\_41425\_34145.jpg

Comment Code					
Inspector Comment					
FS_ID:41425 DS_ID:21565 EP_NO: 5140 Repair Type: Non-Urgent Crossing Status: Indicator Found UCIP Comments: Need to determine more details pertaining to crossing, coordinate with City of Sacramento. Is crossing active? FIELD_STRUCT_DESC: 30-inch diameter condensing water pipe sleeved through 40-inch diameter pipe 5 feet below the crown, annular space grouted. Anchor blocks on both ends, concrete pipes under pads over pipe under railroad. Cap on the waterward end. A 1.5 foot thick by 8 foot high by 8 foot wide reinforced concrete headwall supported on a 2 foot thick by 5.5 foot wide by 12 foot long concrete footing. An 8 foot high by 64 foot wide apron constructed around the waterward end of the pipe at the waterward shoulder of the levee. (Permit No. 5140, State of California-Department of General Services-1967) 18-inch temporary diameter welded steel pipe sleeved through existing 30 inch used to convey water from construction site. (Permit No. 5745-1967) FS Date: 3/6/2013

View of railroad and bike path located on levee crown--wide levee.

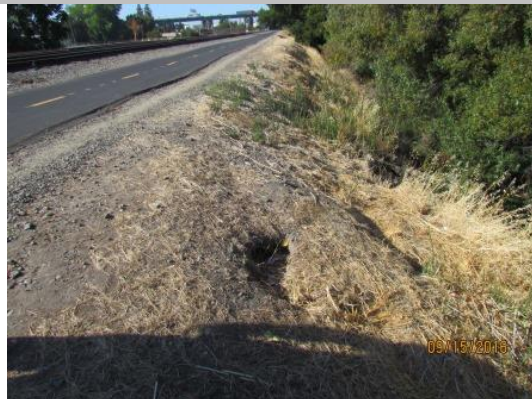
Photo 1 of 1 : FA\_2016\_NA0005\_251\_75\_20160915\_00115.jpg

LM Start	1.25	Rating **	M	Issue No.	75
LM End	1.25	Issue Type +	Ma	Location *	WS
Category	Earthen Levee			GPS Latitude/Longitude	
				Start	End
Item	Animal Control			38.573704 °	38.573704 °
				-121.511219 °	-121.511219 °
DWR ID	DWR_NA0005_01_f_2016_75				
Comment Code					
A3 : No rodents visible, but rodent burrows visible; need to backfill and compact or grout burrows.					
Inspector Comment

View of rodent holes on waterward side of the levee. Fall 2016 inspection.

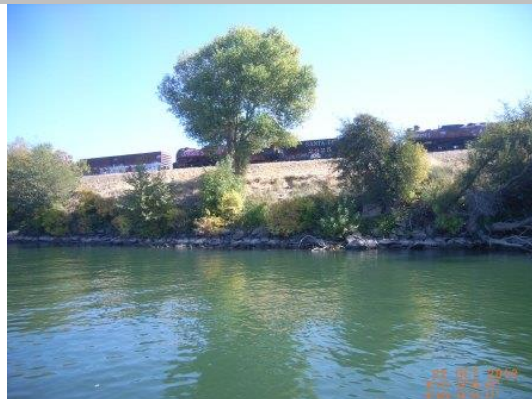
Photo 1 of 2 : FA\_2016\_NA0005\_251\_1\_20160913\_00001.jpg

LM Start	1.31	Rating **	M	Issue No.	1
LM End	1.39	Issue Type +	Ma	Location *	WS
Category	Supplemental			GPS Latitude/Longitude	
				Start	End
Item	2015 USACE Erosion Survey, DRAFT			38.573169 °	38.572277 °
				-121.511998 °	-121.513063 °
DWR ID	DWR_NA0005_01_s_2016_1				
Comment Code					
Inspector Comment					
2008 - Oversized levee, should be repaired under maintenance. 2009 - Shallow slumps at the mid bank. 2010 - Some minor erosion at the toe, likely from wave wash. Some new shallow slumps. 2011 - One new tree has fallen. 2013 - Erosion continues on the slope surface, site extended upstream. 2015: No observed changes. [2015 Site ID: SAC_58-5_L]

USACE 2013 Photo #1

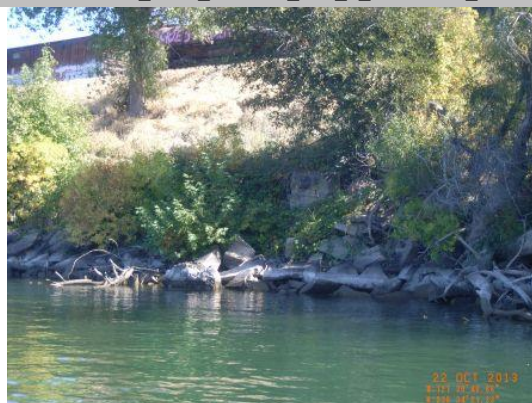
Photo 2 of 2 : FA\_2016\_NA0005\_251\_1\_20160913\_00002.jpg

USACE 2013 Photo #2

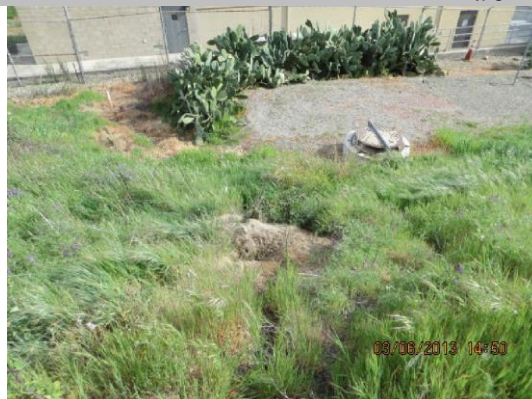
Photo 1 of 2 : UCIP\_FA\_2016\_49767\_34067.jpg

LM Start	<b>1.41</b>	Rating **	M	Issue No.	<b>883 (cont)</b>
LM End	<b>1.41</b>	Issue Type +	En	Location *	WS

View of landward side where crossing should be running through.

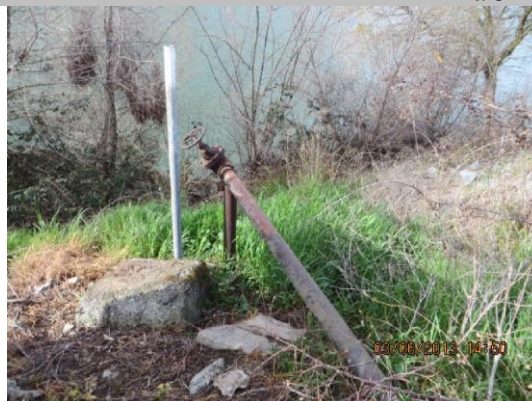
Photo 1 of 2 : UCIP\_FA\_2016\_49957\_34071.jpg

LM Start	<b>1.41</b>	Rating **	M	Issue No.	<b>887 (cont)</b>
LM End	<b>1.41</b>	Issue Type +	En	Location *	WS

View of 6 inch pipe and shut-off valve located on waterward slope.

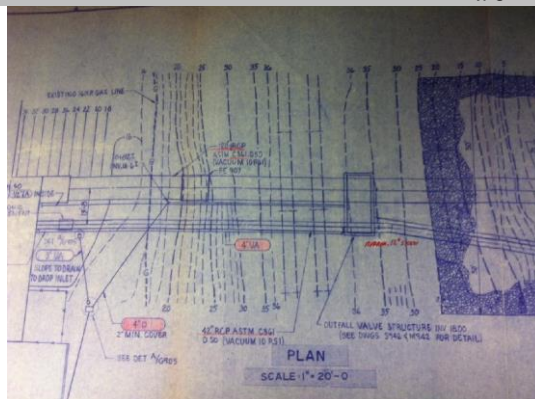
Photo 1 of 2 : UCIP\_FA\_2016\_49778\_34024.jpg

LM Start	<b>1.43</b>	Rating **	M	Issue No.	<b>884 (cont)</b>
LM End	<b>1.43</b>	Issue Type +	En	Location *	WS

DWG showing 42-inch and 120-inch pipes through levee and connection to outfall valve structure.

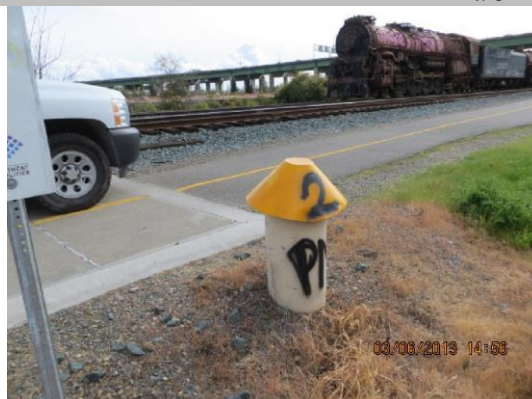
Photo 1 of 2 : UCIP\_FA\_2016\_49958\_34051.jpg

LM Start	<b>1.43</b>	Rating **	M	Issue No.	<b>888 (cont)</b>
LM End	<b>1.43</b>	Issue Type +	En	Location *	WS

View of levee crown--outlet valve structure located along bike path and siphon breaker on waterward shoulder.

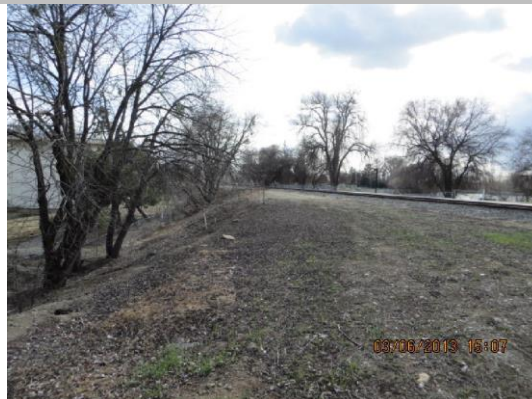
Photo 1 of 2 : UCIP\_FA\_2016\_41442\_59560.jpg

LM Start	<b>1.61</b>	Rating **	M	Issue No.	<b>875 (cont)</b>
LM End	<b>1.61</b>	Issue Type +	En	Location *	WS

View of crossing approximately 110 feet downstream--stand pipes located on landward shoulder.

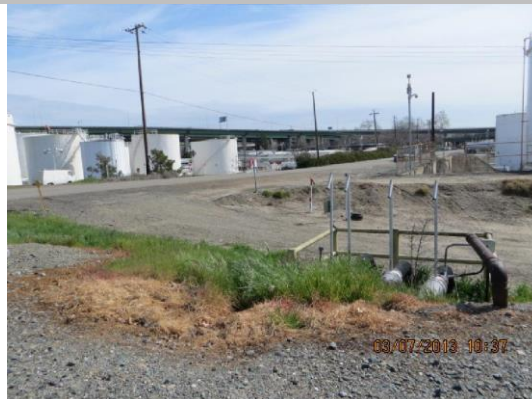
Photo 1 of 2 : UCIP\_FA\_2016\_41452\_59525.jpg

LM Start	<b>1.75</b>	Rating **	M	Issue No.	<b>879 (cont)</b>
LM End	<b>1.75</b>	Issue Type +	En	Location *	WS

View of crossings from levee shoulder.

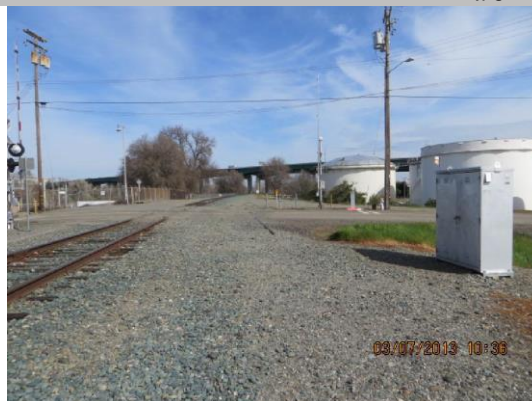
Photo 1 of 2 : UCIP\_FA\_2016\_41448\_59511.jpg

LM Start	<b>1.76</b>	Rating **	M	Issue No.	<b>877 (cont)</b>
LM End	<b>1.76</b>	Issue Type +	En	Location *	WS

View of levee crown looking upstream--rail road traffic signal box located on right side.

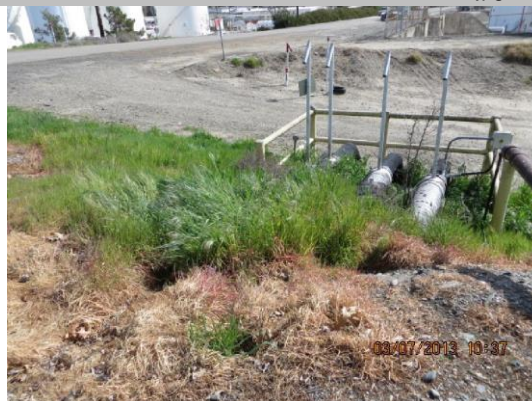
Photo 1 of 2 : UCIP\_FA\_2016\_41449\_59518.jpg

LM Start	<b>1.76</b>	Rating **	M	Issue No.	<b>878 (cont)</b>
LM End	<b>1.76</b>	Issue Type +	En	Location *	WS

View of 4-10 inch pipes through levee located on landward side.

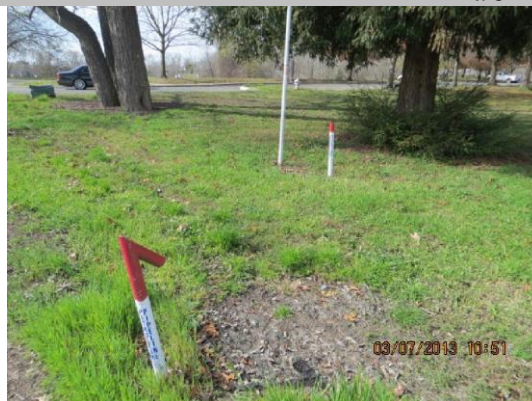
Photo 1 of 2 : UCIP\_FA\_2016\_41457\_59529.jpg

LM Start	<b>1.78</b>	Rating **	M	Issue No.	<b>854 (cont)</b>
LM End	<b>1.78</b>	Issue Type +	En	Location *	WS

View of waterward side--markers visible through levee.

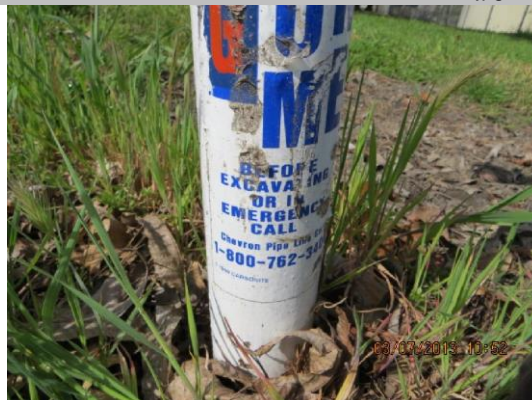
Photo 2 of 2 : UCIP\_FA\_2016\_41457\_59528.jpg

Contact information before excavation or in case of emergency.

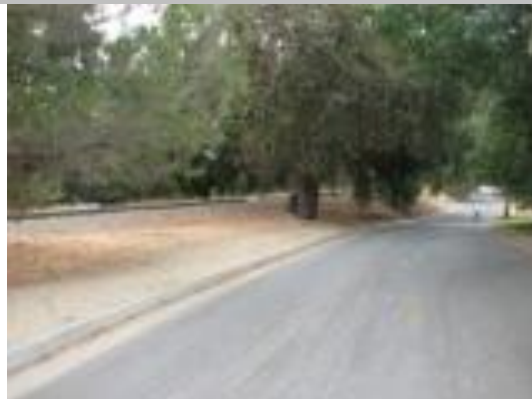
Photo 2 of 4 : FA\_2016\_NA0005\_251\_7\_20160913\_00005.jpg

LM Start	<b>1.95</b>	Rating **	M	Issue No.	<b>7 (cont)</b>
LM End	<b>2.34</b>	Issue Type +	En	Location *	CR

Railroad tracks are on levee crown. The street is to the boat ramp.

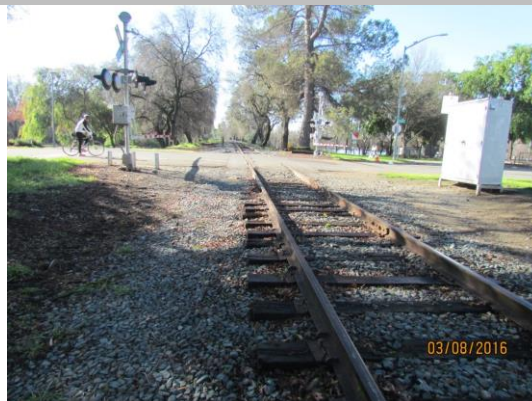
Photo 3 of 4 : FA\_2016\_NA0005\_251\_7\_20160913\_00006.jpg

View of the railroad tracks on the crown of the levee looking downstream at levee mile 1.95. Spring 2016.

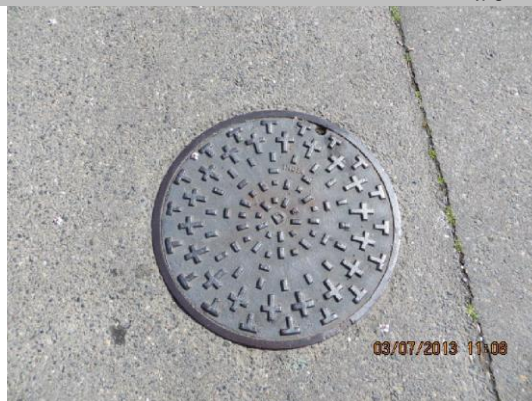
Photo 1 of 2 : UCIP\_FA\_2016\_41430\_72757.jpg

LM Start	<b>1.96</b>	Rating **	M	Issue No.	<b>863 (cont)</b>
LM End	<b>1.96</b>	Issue Type +	En	Location *	CR

Manhole present on roadway.

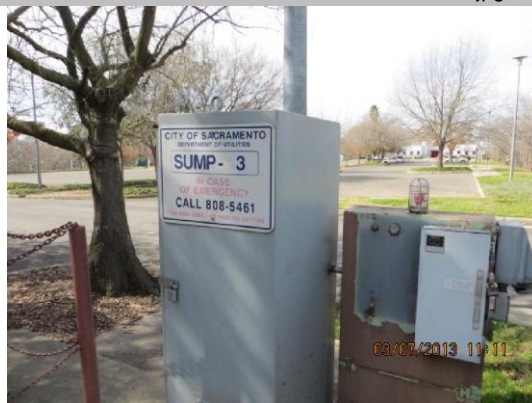
Photo 2 of 2 : UCIP\_FA\_2016\_41430\_72756.jpg

Sump pump station 3.

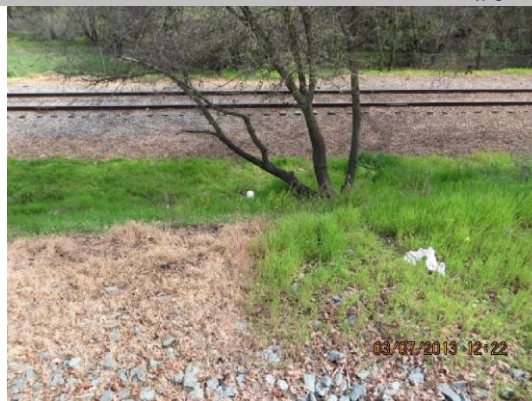
Photo 1 of 2 : UCIP\_FA\_2016\_41293\_72760.jpg

LM Start	<b>2.04</b>	Rating **	M	Issue No.	<b>855 (cont)</b>
LM End	<b>2.04</b>	Issue Type +	En	Location *	CR

PVC pipe through levee.

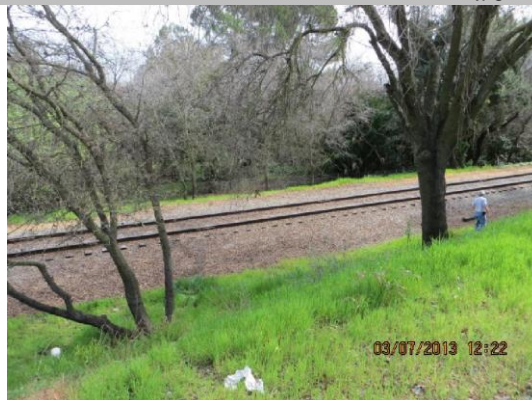
Photo 2 of 2 : UCIP\_FA\_2016\_41293\_72759.jpg

View of landward side.

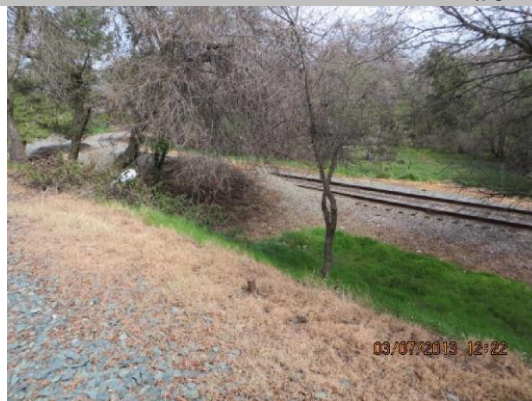
Photo 1 of 2 : UCIP\_FA\_2016\_41295\_72764.jpg

LM Start	2.08	Rating **	M	Issue No.	857
LM End	2.08	Issue Type +	En	Location *	CR
Category	Supplemental			GPS Latitude/Longitude	
				Start	End
Item	DWR UCIP Field Study			38.563196 °	38.563196 °
				-121.515833 °	-121.515833 °
DWR ID					
Comment Code					
Inspector Comment					
FS_ID:41295 DS_ID:24923 EP_NO: N/A Repair Type: Non-Urgent Crossing Status: Indicator Found UCIP Comments: Need to contact owner to determine type of crossing and status. Need to find out the alignment of crossing. FIELD_STRUCT_DESC: 3 of 4. Crossing found through railroad/levee visible on landward side. FS Date: 3/6/2013

View of landward side.

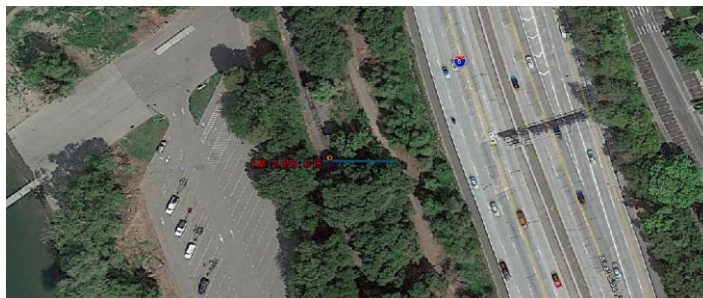
Photo 1 of 1 : UCIP\_FA\_2016\_41431\_72800.jpg

LM Start	2.29	Rating **	M	Issue No.	868
LM End	2.29	Issue Type +	En	Location *	CR
Category	Supplemental			GPS Latitude/Longitude	
				Start	End
Item	DWR UCIP Field Study			38.560088 °	38.560088 °
				-121.515150 °	-121.515150 °
DWR ID					
Comment Code					
Inspector Comment					
FS_ID:41431 DS_ID:24925 EP_NO: N/A Repair Type: Non-Urgent Crossing Status: Indicator Found UCIP Comments: Need to coordinate with owner to determine status of crossing. FIELD_STRUCT_DESC: 18 inch storm drain at unknown depth. Crossing information was obtained from Sacramento County GIS records. (Permit No. 1425, 1949) FS Date: 3/6/2013

Approximate alignment through levee provided by the City of Sacramento GIS.

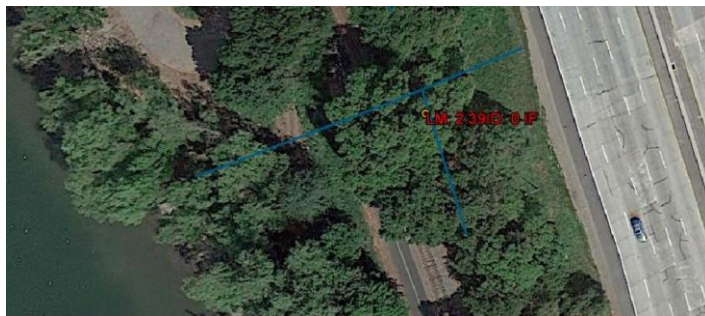
Photo 1 of 1 : UCIP\_FA\_2016\_41433\_72801.jpg

LM Start	2.39	Rating **	M	Issue No.	869
LM End	2.39	Issue Type +	En	Location *	WS
Category	Supplemental			GPS Latitude/Longitude	
				Start	End
Item	DWR UCIP Field Study			38.558793 °	38.558793 °
				-121.514460 °	-121.514460 °
DWR ID					
Comment Code					
Inspector Comment					
FS_ID:41433 DS_ID:24926 EP_NO: N/A Repair Type: Non-Urgent Crossing Status: Indicator Found UCIP Comments: Need to coordinate with owner to determine status of crossing. Unable to find crossing in the field. FIELD_STRUCT_DESC: Unknown pipe size through levee. Crossing information was obtained from Sacramento County GIS records. FS Date: 3/6/2013

Approximate alignment for crossing provided by City of Sacramento GIS.

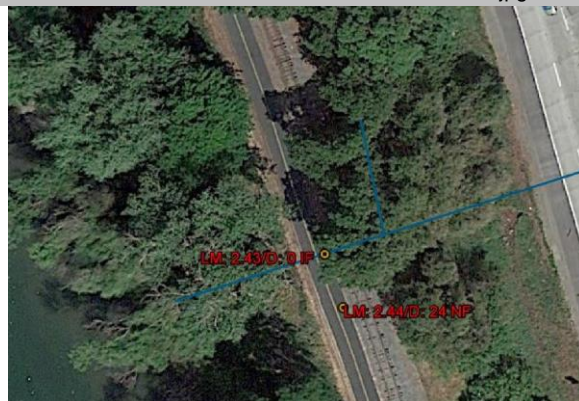
Photo 1 of 1 : UCIP\_FA\_2016\_41296\_72767.jpg

LM Start	2.43	Rating **	M	Issue No.	858
LM End	2.43	Issue Type +	En	Location *	LS
Category	Supplemental			GPS Latitude/Longitude	
				Start	End
Item	DWR UCIP Field Study			38.558224 °	38.558224 °
				-121.514365 °	-121.514365 °
DWR ID					
Comment Code					
Inspector Comment					
FS_ID:41296 DS_ID:24927 EP_NO: N/A Repair Type: Non-Urgent Crossing Status: Indicator Found UCIP Comments: Need to coordinate with owner to determine status of crossing--unable to locate in field. FIELD_STRUCT_DESC: 18 inch storm drain at unknown depth. Crossing information was obtained from Sacramento County GIS records. FS Date: 3/6/2013

Approximate alignment of crossing provided by the City of Sacramento.

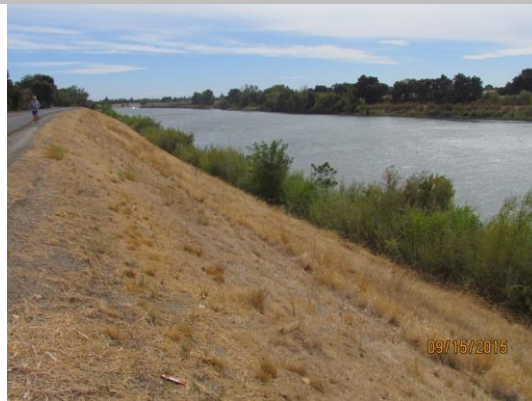
Photo 1 of 2 : FA\_2016\_NA0005\_251\_21\_20160913\_00012.jpg

LM Start	2.46	Rating **	A/W	Issue No.	21
LM End	2.75	Issue Type +	Ob	Location *	WS
Category	Earthen Levee			GPS Latitude/Longitude	
				Start	End
Item	Vegetation			38.557828 °	38.553710 °
				-121.514193 °	-121.512863 °
DWR ID	DWR_NA0005_01_s_2012_21				
Comment Code					
V8 : Environmental Requirements.					
Inspector Comment					
Revegetation site is at the toe of the levee on the waterward side.

View of the revegetation site on the waterward side looking downstream.  
Fall 2015.

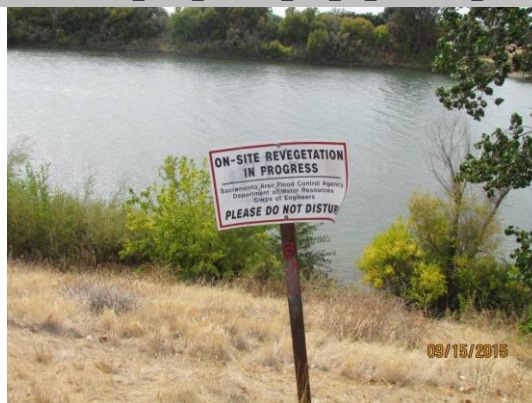
Photo 2 of 2 : FA\_2016\_NA0005\_251\_21\_20160913\_00013.jpg

This area is a revegetation site. Fall 2015.

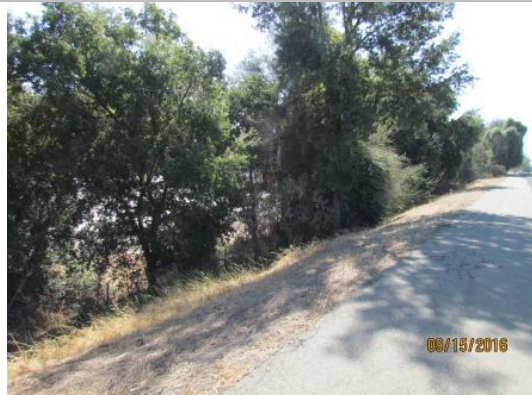
Photo 1 of 1 : FA\_2016\_NA0005\_251\_84\_20160915\_00120.jpg

LM Start	2.52	Rating **	M	Issue No.	84
LM End	2.92	Issue Type +	Ma	Location *	LS
Category	Earthen Levee			GPS Latitude/Longitude	
				Start	End
Item	Vegetation			38.556964 °	38.551504 °
				-121.513926 °	-121.511746 °
DWR ID	DWR_NA0005_01_s_2016_84				
Comment Code					
V2 : Remove the wild growth other than native grasses from the levee slopes.					
Inspector Comment

View of landside slope. Tree trimming and vegetation removal required. Fall 2016.

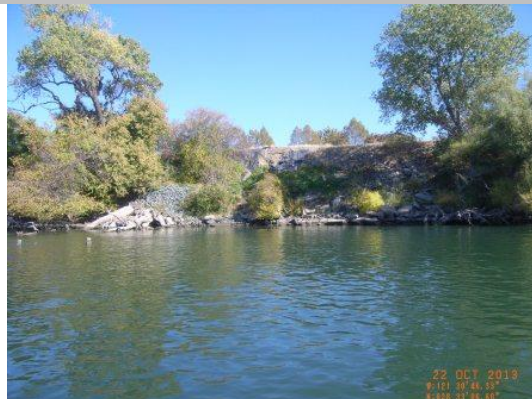
Photo 1 of 1 : FA\_2016\_NA0005\_251\_2\_20160913\_00003.jpg

LM Start	2.85	Rating **	M	Issue No.	2
LM End	2.90	Issue Type +	Ma	Location *	WS
Category	Supplemental			GPS Latitude/Longitude	
				Start	End
Item	2015 USACE Erosion Survey, DRAFT			38.552268 °	38.551578 °
				-121.512590 °	-121.512336 °
DWR ID	DWR_NA0005_01_s_2016_2				
Comment Code					
Inspector Comment					
1997 - Erosion at pump station, concrete debris and plastic showing. 2000 - Separation scour of bank due to poor transition. 2004 - New large tree pop out; city dumped fill dirt/rock into hole. 2006 - Minor new erosion at top of bank. 2010 - Some new rock placed in tree pop-out. 2011 - A large tree has fallen and flood fighting was performed by the city on the upper levee slope. 2012 - Small rock placed in hole from tree popout. 2015: No observed changes. [2015 Site ID: SAC_56-6_L]

USACE 2013 Photo #1

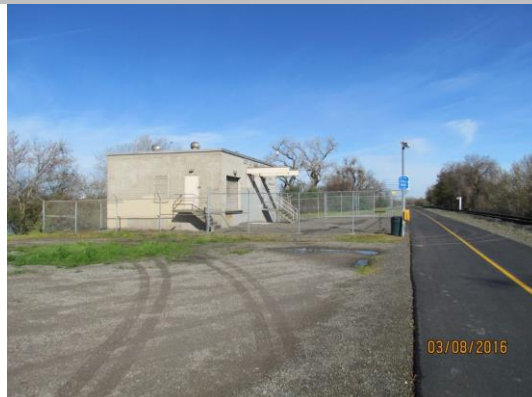
Photo 1 of 1 : FA\_2016\_NA0005\_251\_10\_20160913\_00009.jpg

LM Start	2.89	Rating **	M	Issue No.	10
LM End	2.89	Issue Type +	En	Location *	CR
Category	Earthen Levee			GPS Latitude/Longitude	
				Start	End
Item	Encroachments			38.551810 °	38.551810 °
				-121.511838 °	-121.511838 °
DWR ID	DWR_NA0005_01_s_2012_10				
Comment Code					
BU : Building					
Inspector Comment

View of the City of Sacramento pump station on the waterward side of the levee looking upstream. Spring 2016.

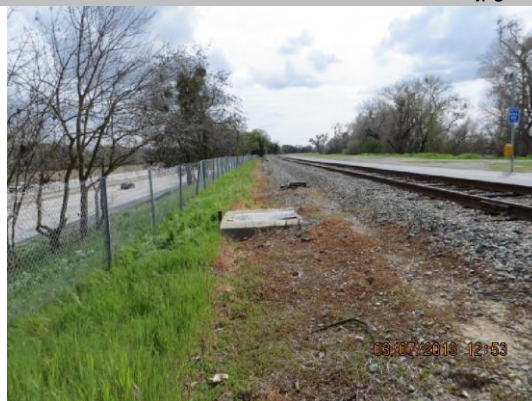
Photo 1 of 2 : UCIP\_FA\_2016\_45133\_59534.jpg

LM Start	2.89	Rating **	M	Issue No.	880
LM End	2.89	Issue Type +	En	Location *	CR
Category	Supplemental			GPS Latitude/Longitude	
				Start	End
Item	DWR UCIP Field Study			38.551797 °	38.551797 °
				-121.511859 °	-121.511859 °
DWR ID					
Comment Code					
Inspector Comment					
FS_ID:45133 DS_ID:21578 EP_NO: 2043 Repair Type: Non-Urgent Crossing Status: Found UCIP Comments: This crossing has been abandoned. According to City of Sacramento Staff the last time this crossing was fired up to see if it was functioning was 3 years ago. Recommend owner coordinating with Central Valley Flood Protection Board (CVFPB) to abandon facility per Title 23. FIELD_STRUCT_DESC: Ranney collector on waterward slope. Ranney collector with 24 inch discharge pipe through levee. (Permit No. 2043, City of Sacramento-1955). FS Date: 3/7/2013

Concrete vault located on landward shoulder.

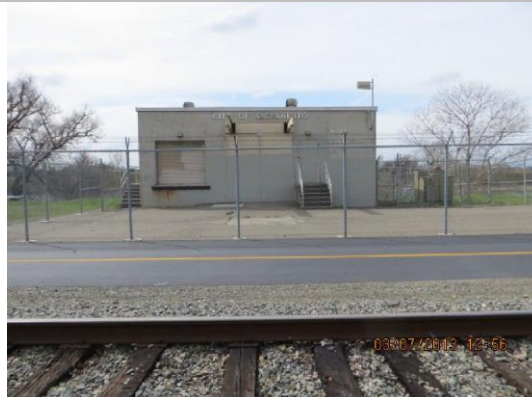
Photo 2 of 2 : UCIP\_FA\_2016\_45133\_59532.jpg

LM Start	2.89	Rating **	M	Issue No.	880 (cont)	
LM End	2.89	Issue Type +	En	Location *	CR	
Category	Supplemental			GPS Latitude/Longitude		
				Start		End
Item	DWR UCIP Field Study			38.551797 °		38.551797 °
				-121.511859 °		-121.511859 °
DWR ID						
Comment Code						
Inspector Comment						
FS_ID:45133						
DS_ID:21578						
EP_NO: 2043						
Repair Type: Non-Urgent						
Crossing Status: Found						
UCIP Comments: This crossing has been abandoned. According to City of Sacramento Staff the last time this crossing was fired up to see if it was functioning was 3 years ago. Recommend owner coordinating with Central Valley Flood Protection Board (CVFPB) to abandon facility per Title 23.						
FIELD_STRUCT_DESC: Ranney collector on waterward slope. Ranney collector with 24 inch discharge pipe through levee. (Permit No. 2043, City of Sacramento-1955).						
FS Date: 3/7/2013

Ranney collector facility operated by the City of Sacramento.

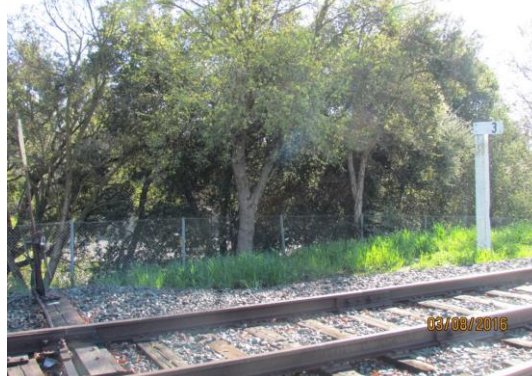
Photo 1 of 2 : FA\_2016\_NA0005\_251\_85\_20160913\_00015.jpg

LM Start	<b>3.35</b>	Rating **	M	Issue No.	<b>85 (cont)</b>
LM End	<b>3.35</b>	Issue Type +	Ma	Location *	LS

View of the trees on the landward side of the levee. Spring 2016.
